# Fortaleza Station: 2010 Status and Antenna Repair

*Pierre Kaufmann, A. Macílio Pereira de Lucena, Adeildo Sombra da Silva*

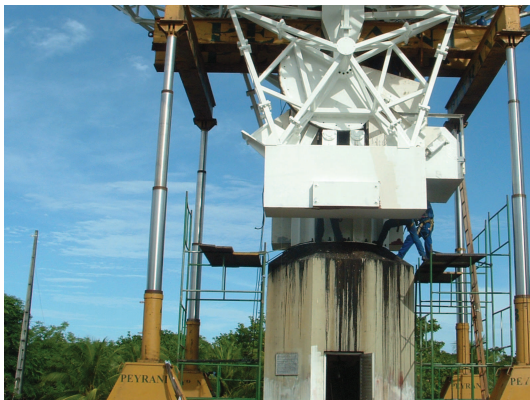
Figure 1. Antenna ready to be lifted up from the azimuth base for bearing replacement.

When searching for companies to provide the repair services, we received proposals from four companies, each offering a different solution. The repair job was awarded to the Brazilian company Robrasa and their installation company partner Peyrani, who had presented the best and most technically consistent bid for the job. Their offer exhibited the best solution in terms of risk, cost, and benefit. The repair consisted of the fabrication of a new bearing, which was performed at the Robrasa factory in Diadema, near São Paulo, and accomplished in six months, and of the new bearing shipment to Eusébio site (the Fortaleza VLBI facility), followed by the replacement. For this, the antenna was lifted up and displaced, the old bearing was removed, the new bearing was put into place, the antenna was relocated, and checks, tests, and azimuth movements were done for final acceptance. The installation was performed over a period of twelve days. All phases were performed successfully and on schedule. A pictorial of the work steps can be found at <http://200.129.55.1>. A rather unique methodology was used by Robrasa. The entire antenna structure, without removal of any pieces, was separated from the tower using hydraulic jacks running on rails, leaving the azimuth area free for the work. Figures 1–6 illustrate the procedure.

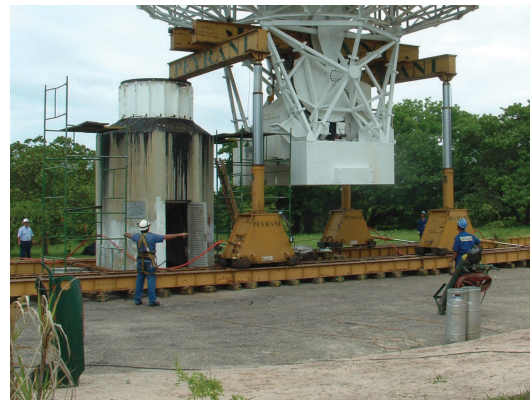
Figure 2. Antenna after being moved to the side of the pedestal.

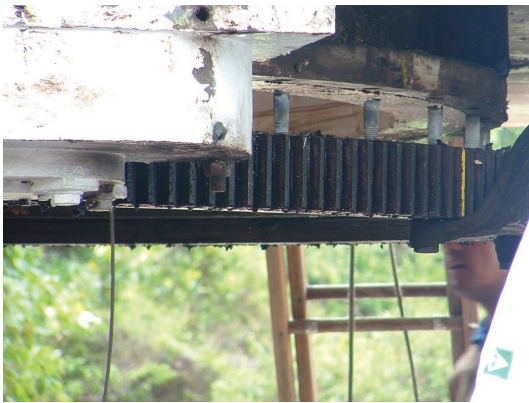
Figure 3. Old bearing being removed.

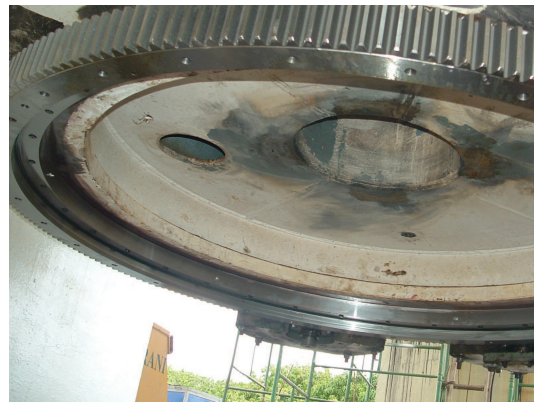
Figure 4. Detail of the new bearing installed.

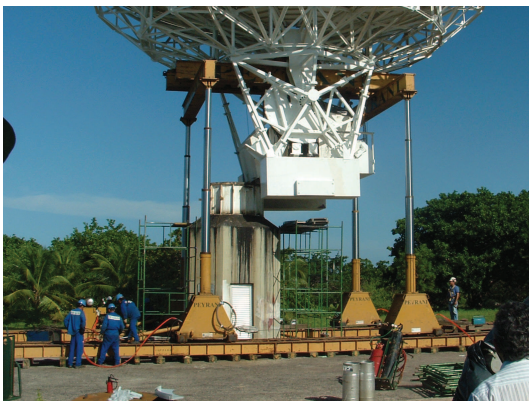
Figure 5. Antenna being moved back.

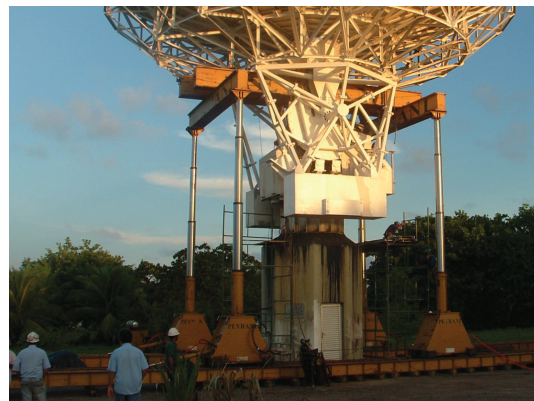
Figure 6. Antenna resting on its base again.
